CONSOLIDATION AND ADHESIVE REPAIR OF VOLCANIC TUFF
CASE STUDY: CONSERVATION OF VOLCANIC TUFF AT THE OLD
STONE CHURCH OF MISSION SAN JUAN CAPISTRANO,
SAN JUAN CAPISTRANO, CALIFORNIA

Evin Hewett Erder

A THESIS

1995

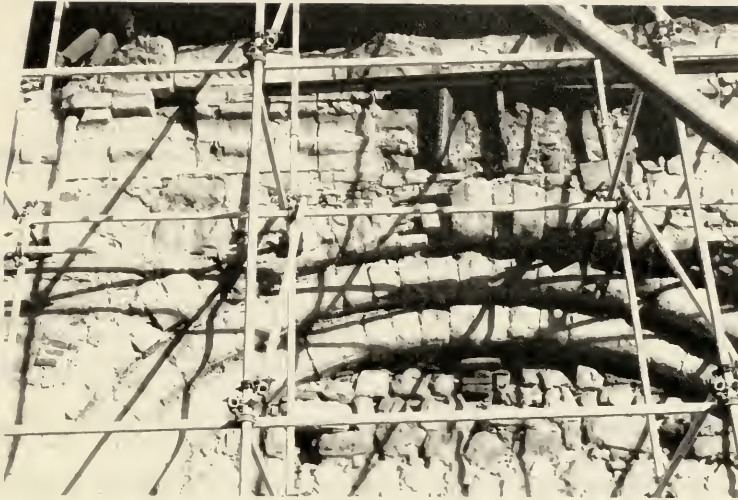
Fig. 14. East wall of nave. Disaggregated and cracking tuff blocks in cornice.

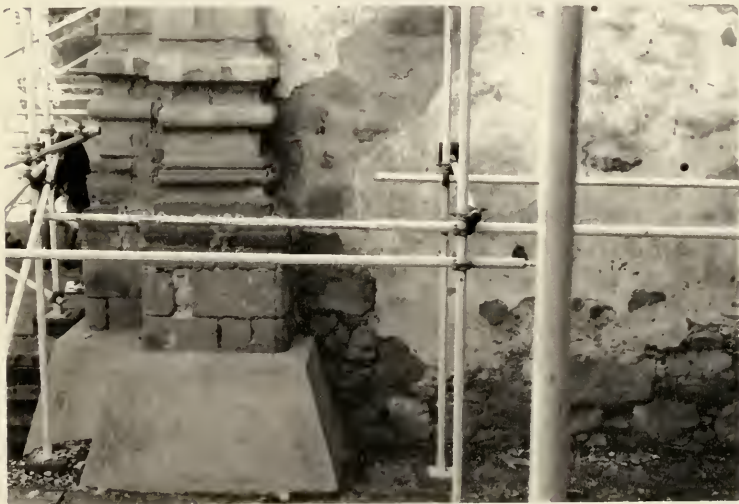
Fig. 15. North wall of east transept. Cementitious mortar repairs on stones, around edges of plaster, and as encasement of pilaster base at north wall of east transept.

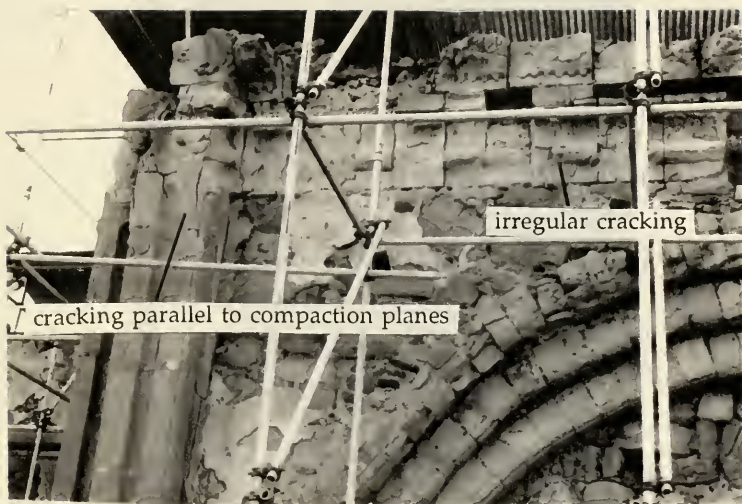
(3) **microcracking** (> 1 mm.) is usually localized and confined to a single block. This condition predominates in volcanic tuff blocks and yellow sandstones in irregular patterns (i.e., map cracking) and is normally caused by inherent weaknesses in the stone, moisture penetration, surface hardening, and internal geo-physical stresses.

Fig. 18. Cracking of volcanic tuff blocks in pilaster and cornice in east wall of nave.

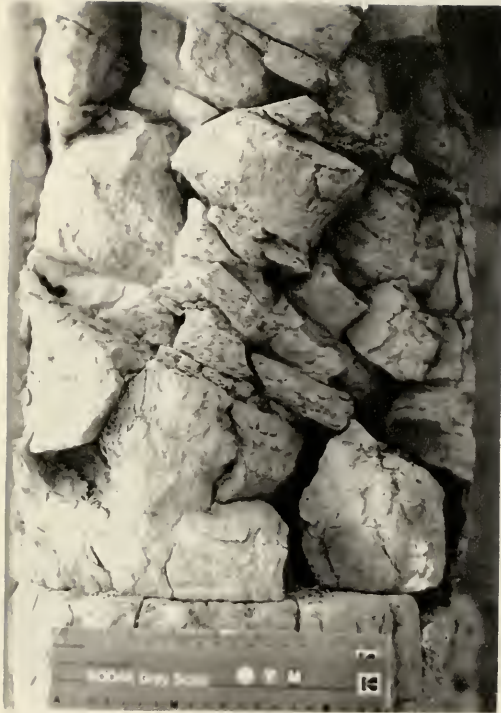
Fig. 19. Irregular and diagonal cracking of volcanic tuff blocks at intersection of west wall of nave and transept (Photo: Anne Brackin).

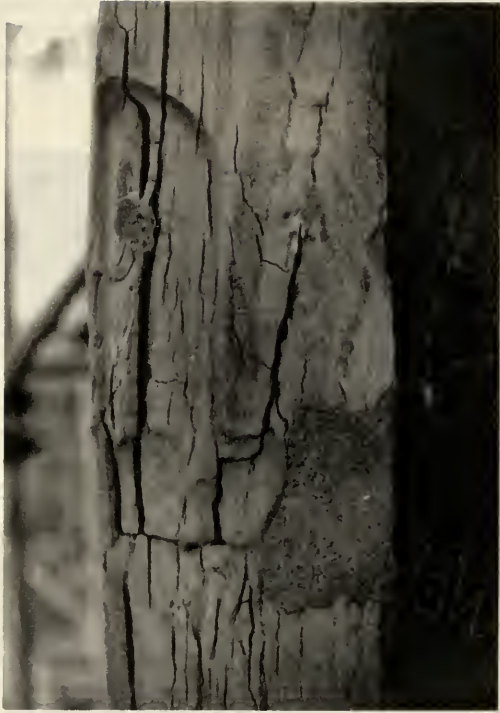
Fig. 20. Vertical cracking along bedding planes of tuff at intersection of east wall of nave and transept. Cementitious mortar repair in areas of loss (Photo: Anne Brackin).

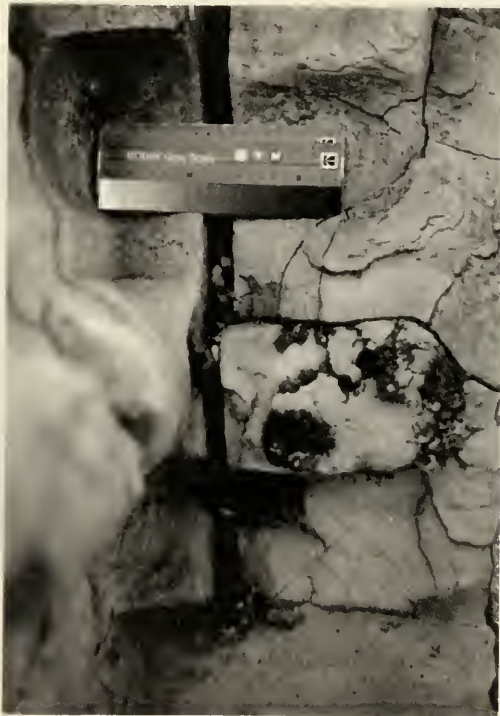
The presence of algae, lichens, and other microflora and higher plant growth may be found either in cracks, open joints, or on the surface of stones in areas of high moisture. Vegetation and plant roots predominate in open joints in volcanic tuff blocks in the upper tier of the cornice in sheltered areas on the west and south walls. A black growth, probably a combination of algae and lichen, predominates in the volcanic tuff in isolated areas exposed to adequate light and moisture at the intersection of walls and on blocks in the lower tiers of cornices.

Fig. 21. Biological growth on tuff at intersection of west wall of nave and transept adjacent to open joints and cracks (Photo: Anne Brackin).

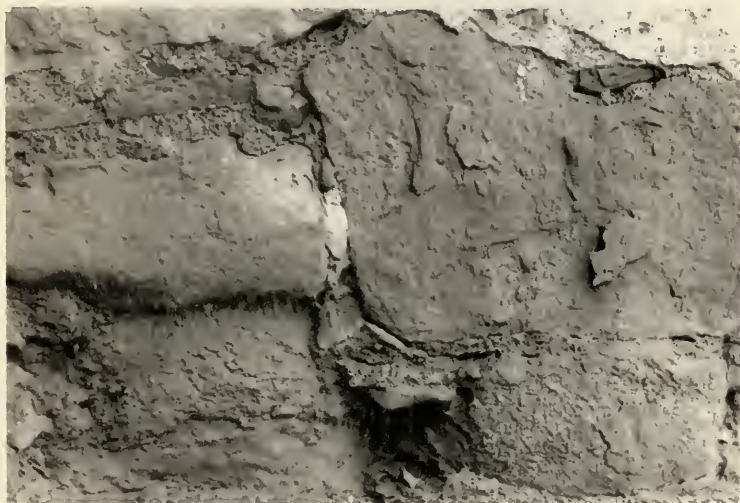
Active detachment and loss of small, thin flakes of stone not necessarily in association with bedding planes or stone orientation. This condition occurs in the green and yellow sandstone and volcanic tuff blocks with their preferred direction of compaction or bedding planes parallel, perpendicular, or diagonal to the surface of the wall. This condition is most severe in the first two courses of stones above the base of walls, in areas exposed to moisture and sunlight, and appears to be related to soluble salt formation.

Fig. 22. Flaking of green sandstones above base of wall at north wall of east transept.

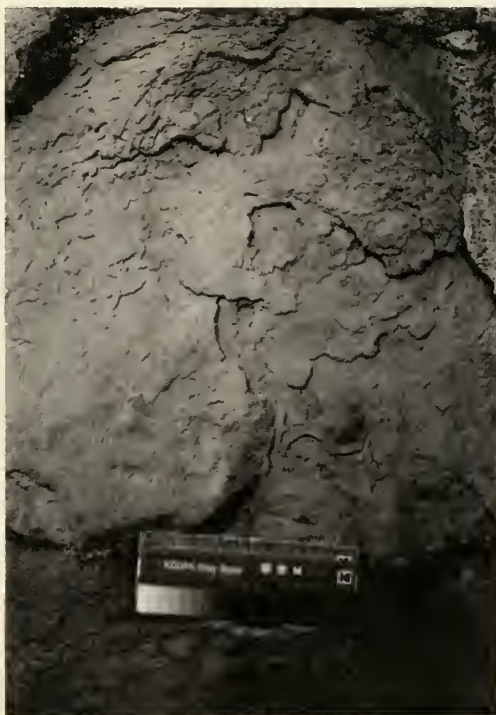
Localized uneven loss of layers of stone, often of uniform thickness, which occurs in a step-like pattern creating contoured depressions associated with bedding and stone orientation. This condition occurs in volcanic tuff blocks and yellow sandstones with distinct bedding planes parallel, perpendicular, or diagonal to the surface of the wall, in the pilaster capitals and shafts, upper and lower tiers of the cornices, and the arches on the west and east walls of the nave. The condition is most severe in unprotected blocks exposed to light and moisture.

Fig. 23. Contour scaling and flaking of green sandstone 3' above grade at east wall of east transept (Photo: Anne Brackin).

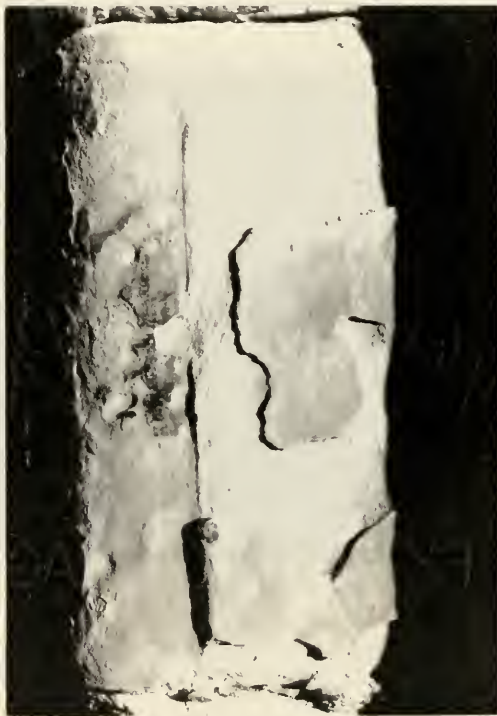
This constitutes detachment and loss of one or more surface layers of stone of uniform thickness and parallel to each other in association with bedding and stone orientation. The condition predominates in green and yellow sandstones with bedding parallel to the surface of the wall at the bases of walls and pilasters. It is normally caused by the penetration and capillary rise of ground water, and the formation of soluble salts, and wet-dry cycling.

Fig. 24. Exfoliation of yellow sandstone at base of arch in east wall of nave (Photo: Anne Brackin)

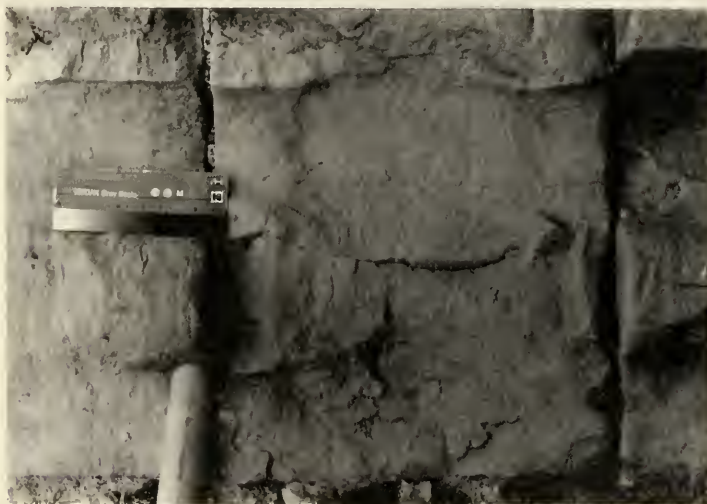
Defined as partial or complete loss of stone often in association with exfoliation, disaggregation and previous repairs. This condition predominates in volcanic tuff and sandstone blocks with narrow to wide cracking (1 mm. to 10 cm.) or contour scaling. In addition, losses occur in unprotected areas exposed to the weather where disaggregation of the stones leads to surface erosion. All loss results in an incompleteness of form or carved decoration.

Fig. 25. Cracking and partial loss of tuff at cornice level in west wall of nave (Photo: Anne Brackin).

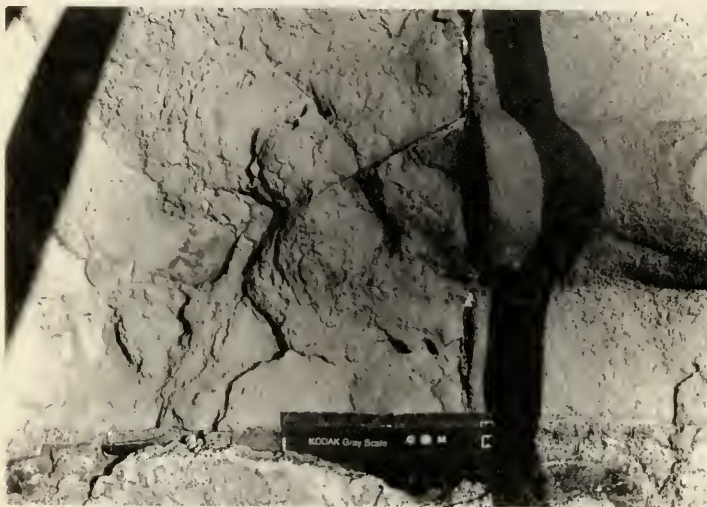
Planar or linear discontinuities are defined by (1) uninterrupted deformation or distinct fragmentation in association with cracking or loss within a single block, or by (2) misalignment of adjoining elements. This condition predominates in volcanic tuff blocks in the cornices, pilasters, and around the doorways in the apse and is normally caused by continuous cracking and gross structural movement.

Fig. 26. Cracking and displacement of tuff at cornice level at east wall of apse (Photo: Anne Brackin).

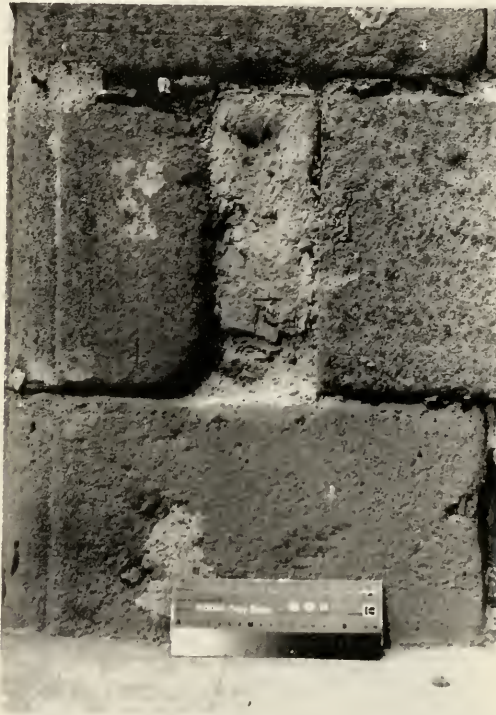
Active detachment of grains resulting in a rough, granular appearance, and overall friability of the stone surface. The condition predominates in unprotected volcanic tuff blocks at the cornices and pilaster capitals and in sandstone blocks at the bases of walls. The causes are usually moisture and salt penetration, and wet-dry cycling.

Fig. 27. Disaggregation of tuff at pilaster base at the intersection of the apse and east arm of the transept (Photo: Anne Brackin).

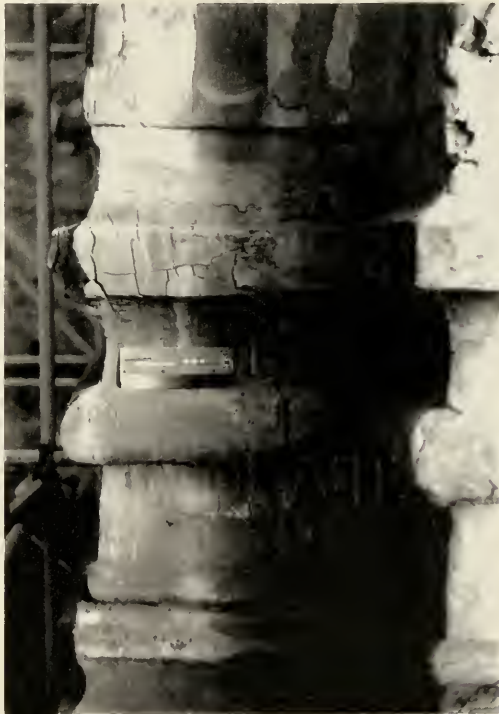
Complete or partial loss, cracking, or separation of mortar within the masonry joints. This condition predominates in high exposure and moisture areas in the tuff at the cornices, pilaster capitals and bases, and the sandstone blocks at pilaster bases and arches on west and east walls of the nave. Open or defective joints are normally caused by: moisture penetration and differential expansion and contraction or movement of the mortar within the joints and adjoining stones, efflorescence, and biological growth.

Fig. 28. Open and defective joints at base of pilaster at the intersection of the east transept and east wall of nave (Photo: Anne Brackin).

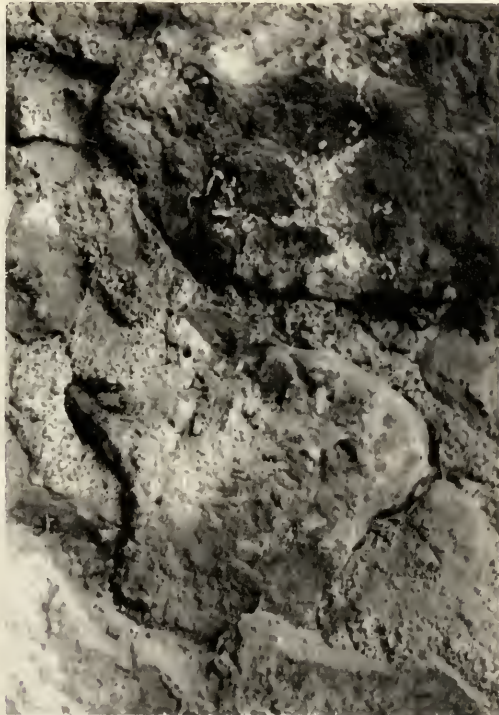
White crystalline surface deposits composed of water-soluble salts, often found in areas of water penetration. This condition predominates in yellow and green sandstone blocks located at the bases of walls and pilasters 1'-2' above grade. The cause is normally the penetration and capillary rise of ground water and associated soluble salts through the stone. As the stone dries, these salts crystallize on or below the surface as cryptofluorescence and present a significant cause of deterioration in sandstone blocks above grade level. The rapid wetting and drying in these areas results in severe exfoliation, contour scaling, and flaking due to the internal disruptive pressures of the crystallized salts in the stone pores.

Fig. 29. Efflorescence on sandstone 1.5' (46 cm.) above grade at northeast wall of apse.

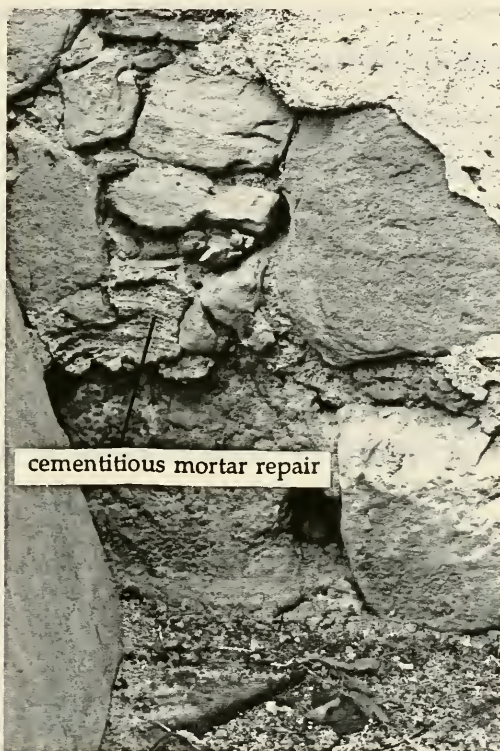
Subsequent alterations made for structural, aesthetic or functional reasons, such as mortar patching and stone dutchmen, cracking, flaking, contour scaling and exfoliation. Repairs on the interior of the Old Stone Church occur primarily in volcanic tuff blocks at the cornices, pilaster capitals, shafts and bases, and the doorways and sandstone arches in the apse. Repointing of these mortar joints occurs throughout the interior of the church. The specific locations of the repointing campaigns, however, have not been recorded in previous documentation conditions. The stone behind and around mortar repairs show signs of efflorescence and disaggregation. Some significant losses of stone occur, especially adjacent to cementitious repairs, suggesting a relationship between the inappropriateness of the repair and the condition.

Fig. 30. Cementitious mortar repairs and associated efflorescence above grade at the intersection of the apse and east arm of the transept.
